Automatic Transmission & Transaxle Work Example 1

Automatic Transmission & Transaxle Work Example 2

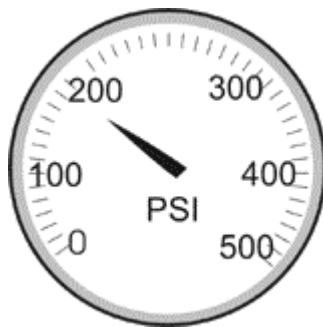
Neutral (Park)

Manufacturer's specs state that pressure readings in drive should be within 10% of pressure readings in neutral. Is the drive reading as indicated below within spec? What are the possible explanations for this? What would be a possible customer complaint?

No, the drive reading is not within specs. An acceptable spec range is $\pm 10\%$ of park.

$$(\text{park})(10\%) = (\text{appx. } 180)(0.10) = 18 \text{ psi}$$

$$162 \text{ psi} \leq \text{reading} \leq 198 \text{ psi}$$

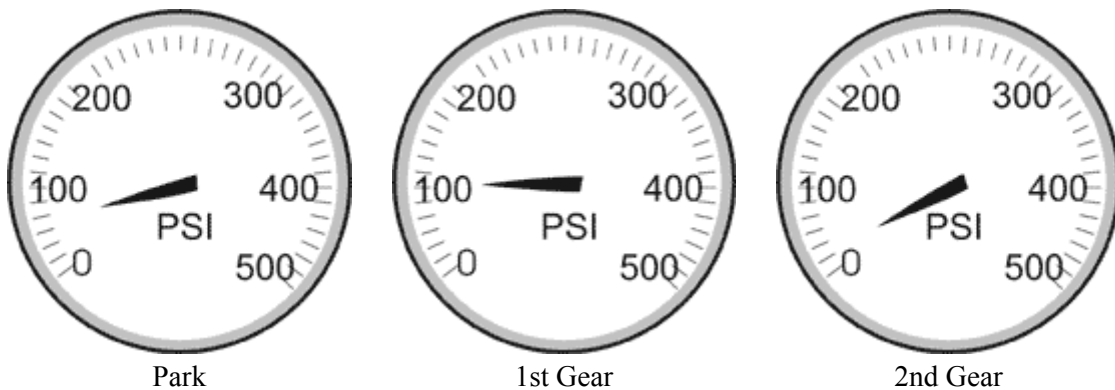
Manufacturer's specs state that pressure readings in drive should be within 10% of pressure readings in park. Are the drive readings as indicated below within spec? What are the possible explanations for this? What would be a possible customer complaint?

The first gear is within specs; however, the second gear is not within specs.

A possible explanation would be internal leakage for the second-gear components.
